STAIRWAY TO HEAVEN

Degraded by damp, drafts and fragmenting plaster over centuries, the theatrical wall paintings commissioned by socialite William Cavendish to dramatise visitors' journeys up to the heavens at Bolsover Castle in Derbyshire are now being rescued to share their stories

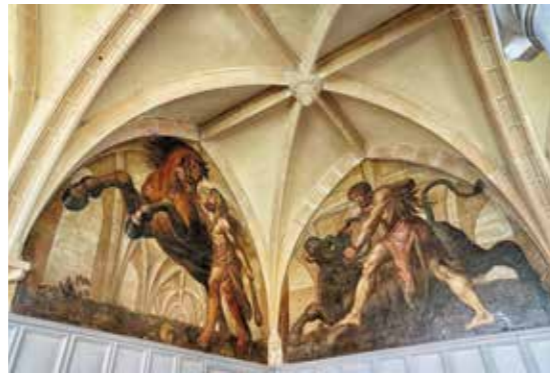
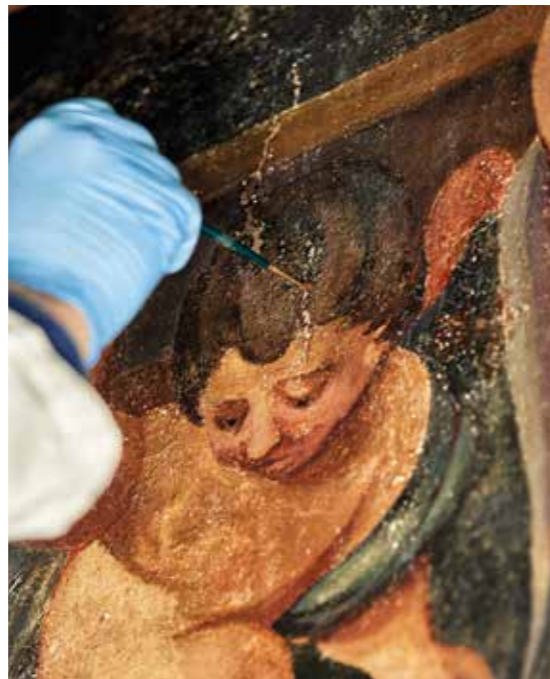
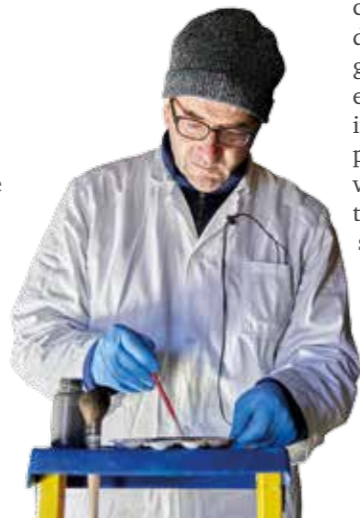
Clockwise from above
Painting over the cracks in the Heaven Closet; paintings depicting Hercules' labours on the vaulted ceiling of the Servants' Hall; conservator Francesco Rosillini in the Heaven Closet; mixing paint to retouch the worst affected areas

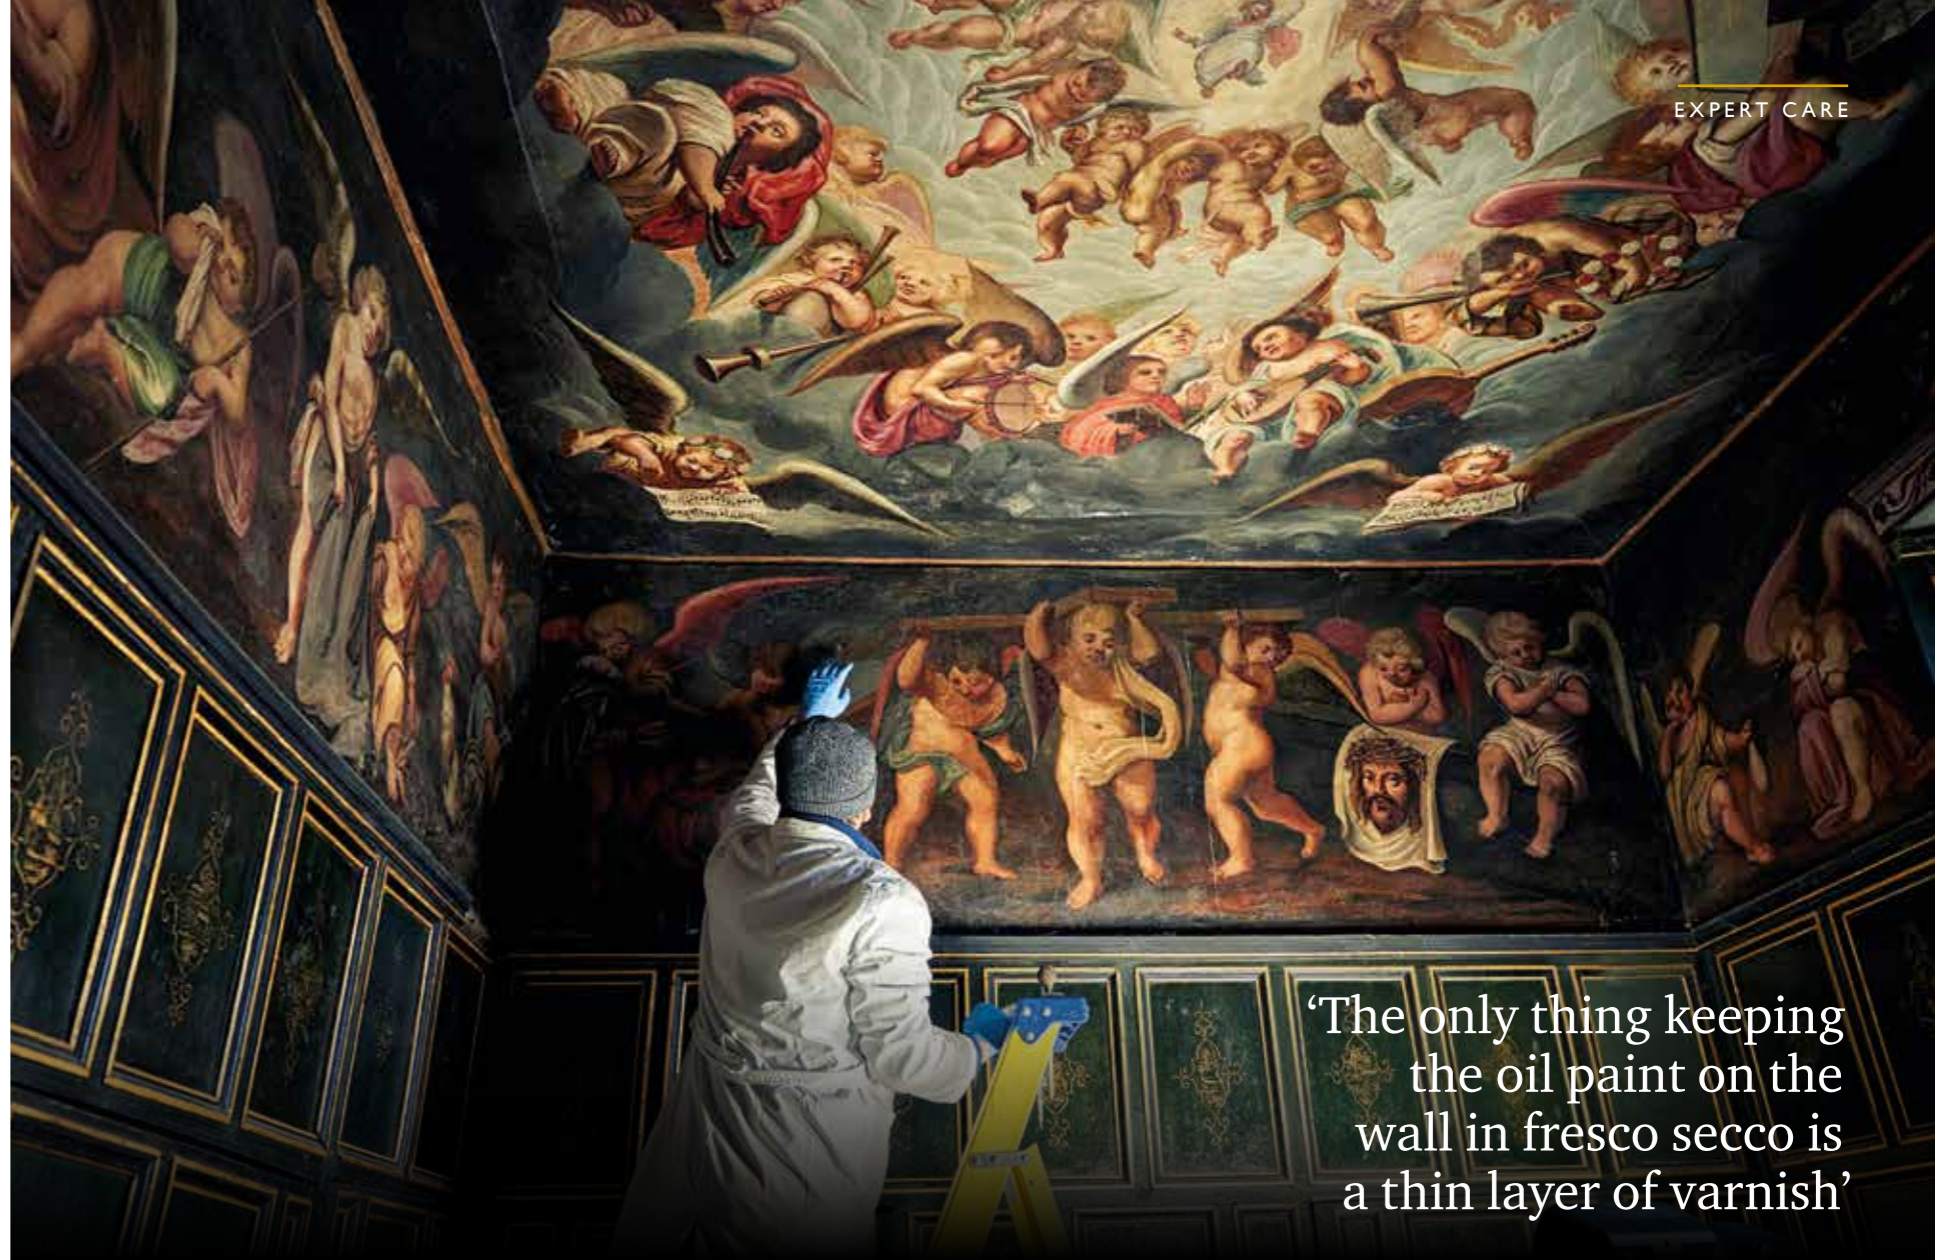
Conservator Francesco Rosillini adds the finishing touches to a damaged section of the Heaven Closet ceiling at Bolsover Castle, in which several cherubs are depicted carrying a crucifix.

'Very scary,' agrees Sophie Stewart of wall paintings specialist Paine & Stewart, pointing out an enormous bulge in the plaster, a forest of drip marks and copious flaking on the surface of the painting. The bulge and drips are water

damage, and the flaking is a result of the inclement conditions. These cherubs are not in a good way.

Turnbull puts away her torch and makes space on the ladder for Francesco Rosillini, whose work we've interrupted. His white coat and surgical gloves create a decidedly medical atmosphere that's at odds with the romance and delicacy of these English Renaissance paintings. The enormous syringe he's brandishing only adds to the effect. Slowly and carefully, through pre-existing cracks in the bulging plaster, Rosillini injects the syringe's contents – a specially mixed grout of lime and trass containing minute glass beads for lightness – into the empty space behind it. Once this grout has dried, the area will be stable and Turnbull will be able to breathe a sigh of relief.

well as the Heaven Closet. Rosillini will be based at the Little Castle for two weeks, using vinegar to carefully remove the drip marks, injecting conservation-grade adhesive under flaking paintwork to stabilise it, and doing retouches to areas where paint has been subject to blanching or has flaked off entirely.

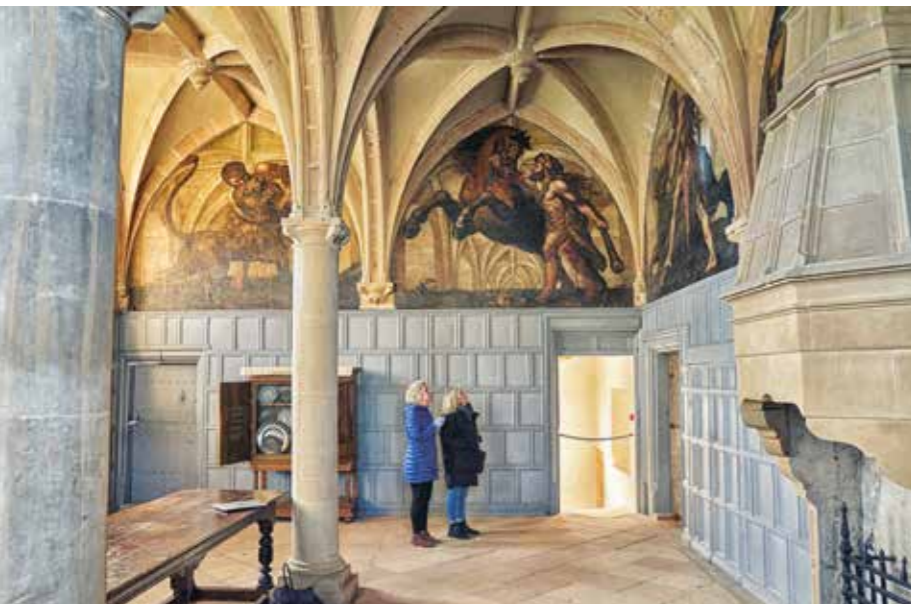
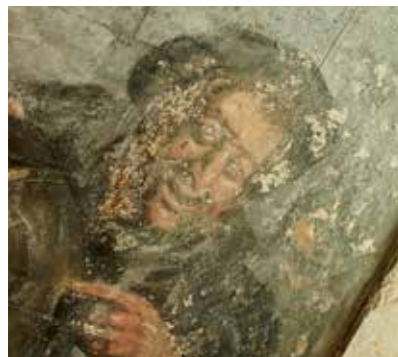
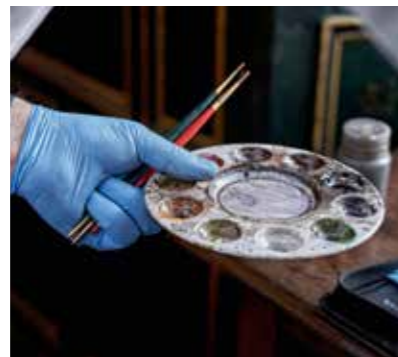
Clockwise from top
Conservators Sophie Stewart and Rachel Turnbull inspect the paintings of Hercules’ labours in the Servants’ Hall; mixing the perfect palette of colours; damp and drafts have taken their toll on the castle’s plasterwork
